# Manhole Inspection Summary

Manhole # S55G\_\_001MH

Insp Date: **8/17/09 11:52 AM**

**Location** Address: **320 S. Fagley St.**

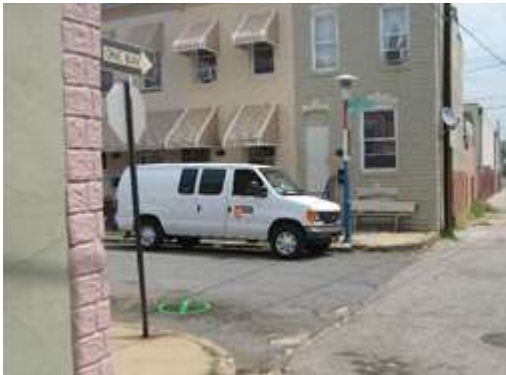
Location View

View facing eastward

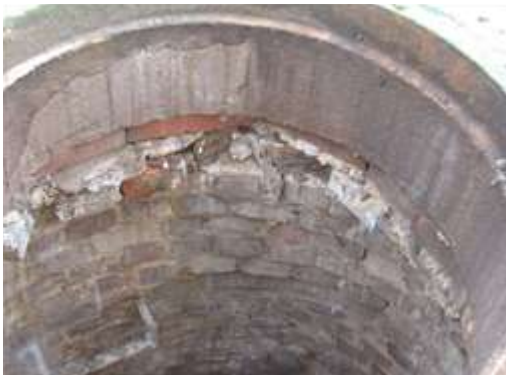
Defect 3

Condition: ☐ Sound ☐ Cracked ☐ Root Intrusion ☐ Loose Brick ☒ **Deteriorated**

deteriorated chimney

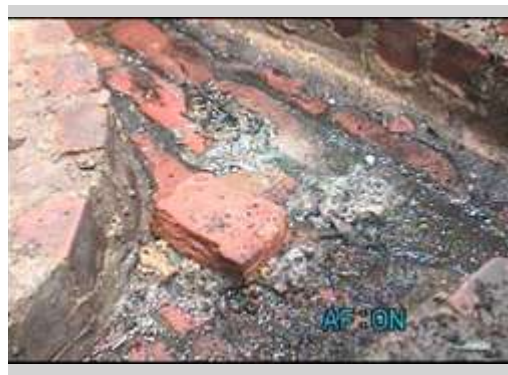
Defect 2

Condition: ☐ Sound ☐ Cracked ☐ Root Intrusion ☐ Deteriorated ☐ Leaks ☒ **Debris**

debris in the channel

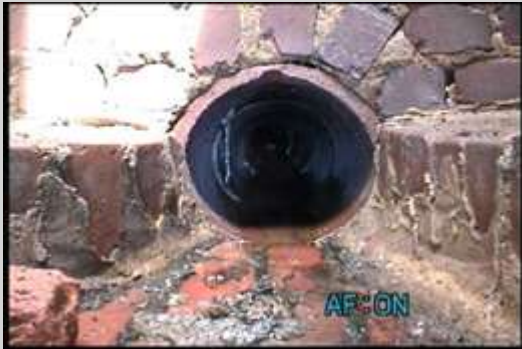
12 O'Clock Outflow

8 in. Circular Gravity Sewer  
Pipe Out @ 12 O'Clock

Pipe Height: **8.4** (in.) Rod and Bar (Angled)

Pipe Material: **Clay** ☐ Pipe Lined

Invert Depth: **5.70** (ft.) Flow Characteristics: **None**

Infiltration: **None** Pipe Seal Cond: **Sound**

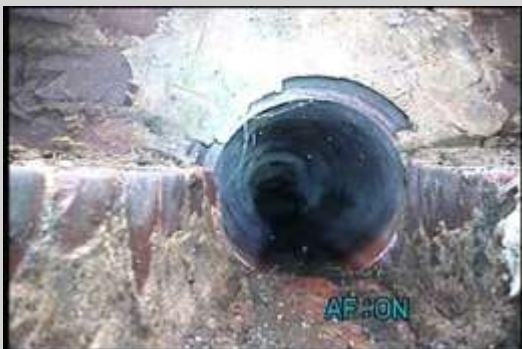
6 O'Clock Inflow

8 in. Circular Gravity Sewer  
Pipe In @ 6 O'Clock

Pipe Height: **7.2** (in.) Rod and Bar (Angled)

Pipe Material: **Clay** ☐ Pipe Lined

Invert Depth: **5.50** (ft.) Flow Characteristics: **None**

Infiltration: **None** Pipe Seal Cond: **Sound**

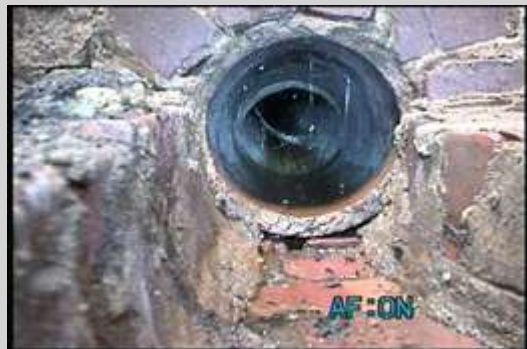
9 O'Clock Inflow

6 in. Circular Gravity Sewer  
Pipe In @ 9 O'Clock

Pipe Height: **6** (in.) Rod and Bar (Angled)

Pipe Material: **Clay** ☐ Pipe Lined

Invert Depth: **5.38** (ft.) Flow Characteristics: **None**

Pipe Seal Cond: **Unknown**
